AN INVESTIGATION OF OVER-HEATING AND  
ROCK-LIKE FRACTURE OF STEEL 18Cr2Ni4WA

Source: Acta Metallurgica Sinica, Vol 13, Nr. 3,  
September 1977, pp. 187-192

An Investigation of Over-heating and  
Rock-like Fracture of Steel 18Cr2Ni4WA

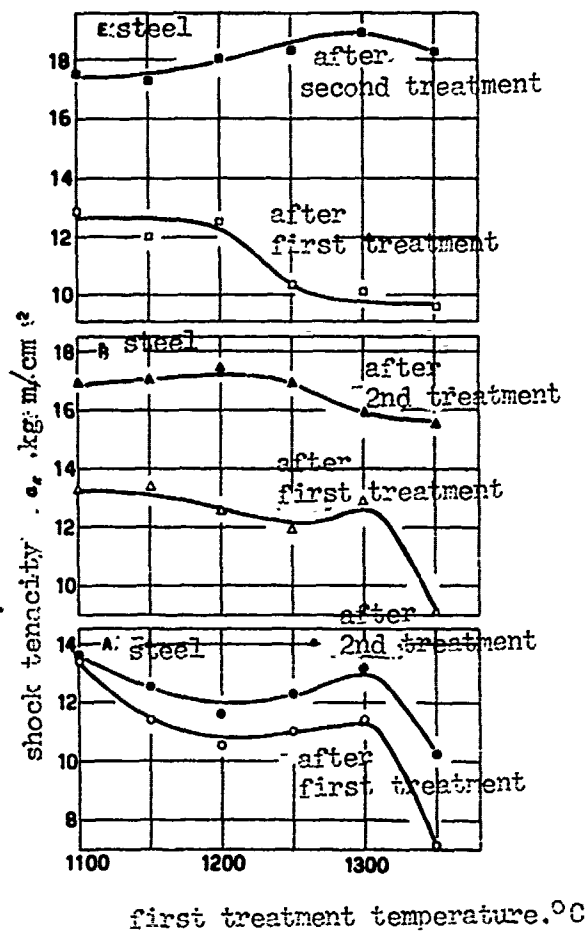
Figure 2 Comparison of sensibility to over-heating of steel A, B, and E

Of steel A, after a treatment at 1350°C, the shock tenacity value

rapidly becomes low, and correspondingly the fracture becomes typical rock-like fracture and it cannot even improve after second treatment. The austenite grain begins coarsening when it is at 1200°C. The average diameter of the grain is about 2.7mm when the temperature reaches 1350°C and the greatest diameter is 4 mm or so.

Of steel B, after treatment at 1350°C, the shock tenacity value also becomes remarkably low, but it can restore after second treatment. The grain will not begin coarsening until the temperature reaches 1300°C and the fracture of the testing samples shows no over-heating small plane at 1350°C treatment.

The changes of shock tenacity value and the fracture of steel C are similar to steel B. Steel D is similar to steel A.

Of steel E, the temperature at which the shock tenacity value becomes unusually low after first treatment is 1250°C. It seems that this steel is easy to be over-heated and it will improve noticeably after second treatment. The examination of its fracture shows that it will begin to have grain-like cross-section when temperature reaches 1300°C, and its appearance looks like rock but it is not rock-like fracture and it can restore after second treatment.
